Priory Church of St Mary & St Michael, Cartmel, Cumbria

Statement of Significance

Prepared for the PCC of St Mary's, Cartmel

Marion Barter Associates Ltd

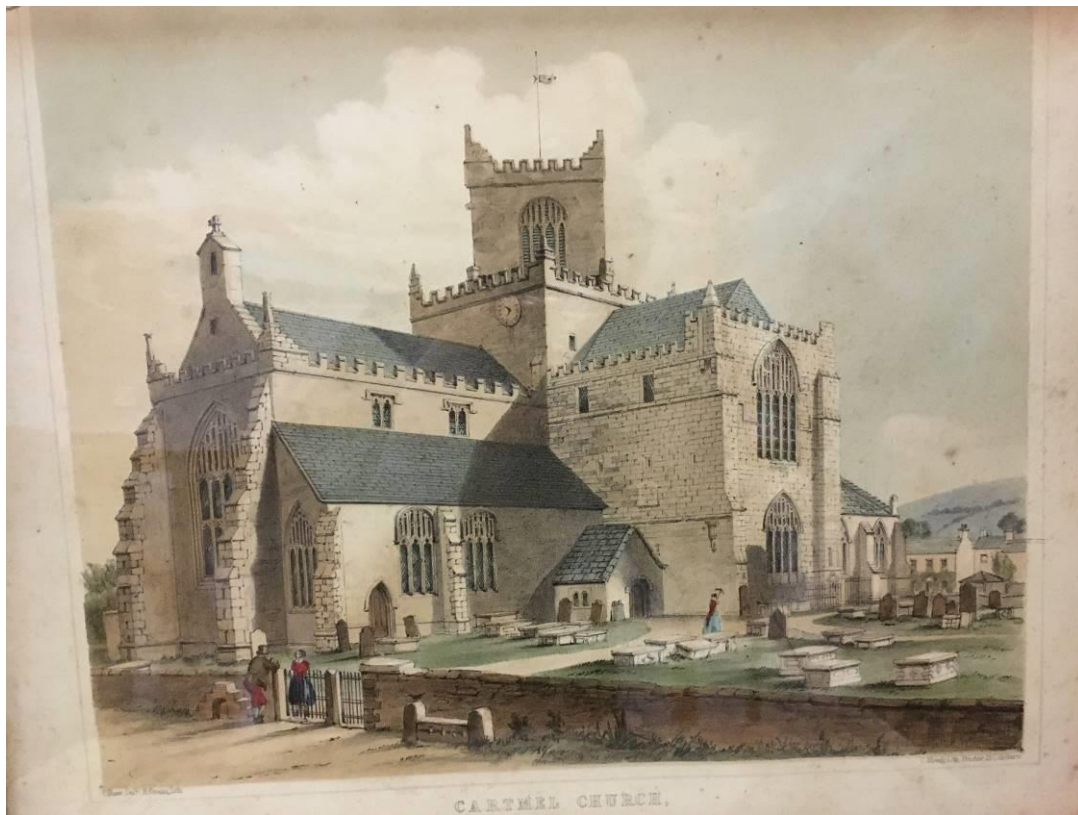
Fig.3: view of church before external render was removed, c.1840 (Cartmel Priory collection)

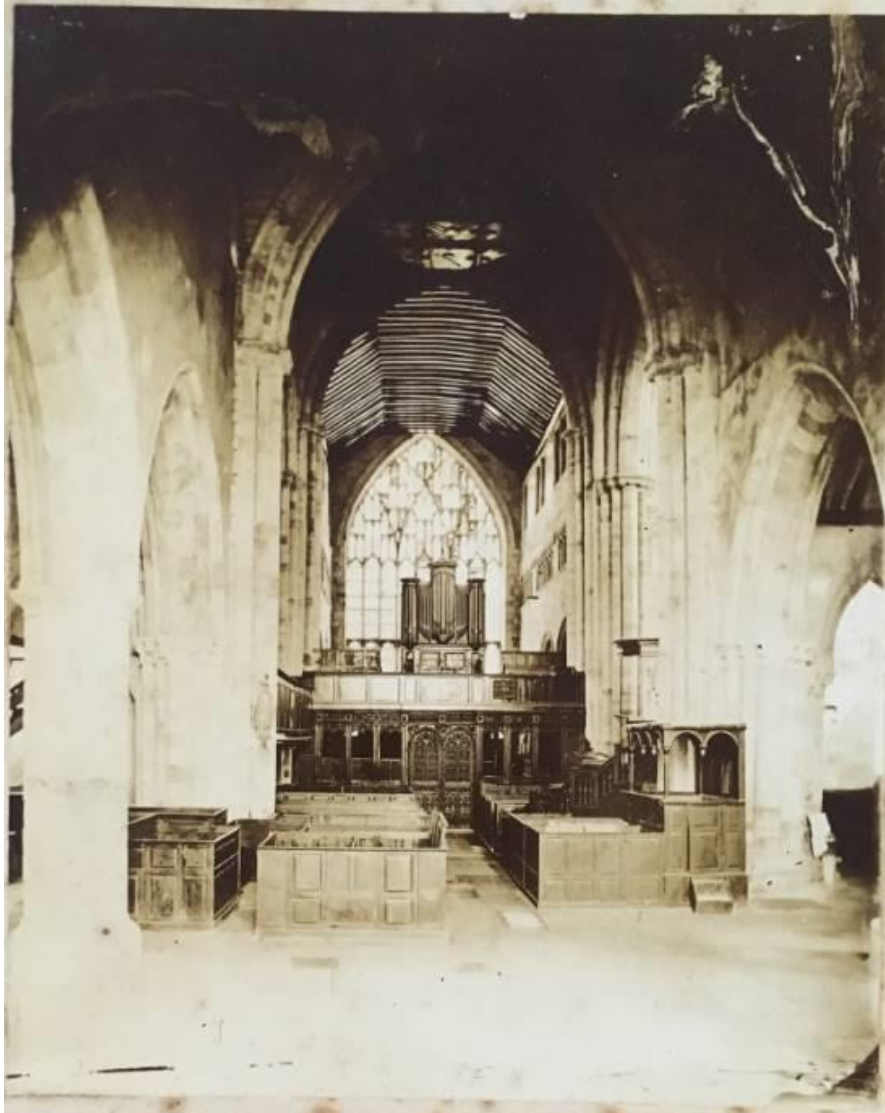
Fig 5: the nave and crossing in a photograph of c1860, from the west (Cartmel Priory collection)

The death of the Rev Remington in 1854 led to a pause in renovation, which was renewed in 1857-8 when the Chancel was re-roofed and *'the interior plaster ceiling, which had become dangerously decayed, was taken down, and the timber Roof thoroughly repaired; the walls, pillars, and arches were cleaned from whitewash; and a very striking feature of the Church which had been blocked up and almost obliterated, namely the Triforium, was opened and completely restored'* (CAC(B) WPR/89/4/2/12 1873-1957). The results of this work are recorded in the early photograph below, which also shows the box pews and organ over the chancel screen before removal.

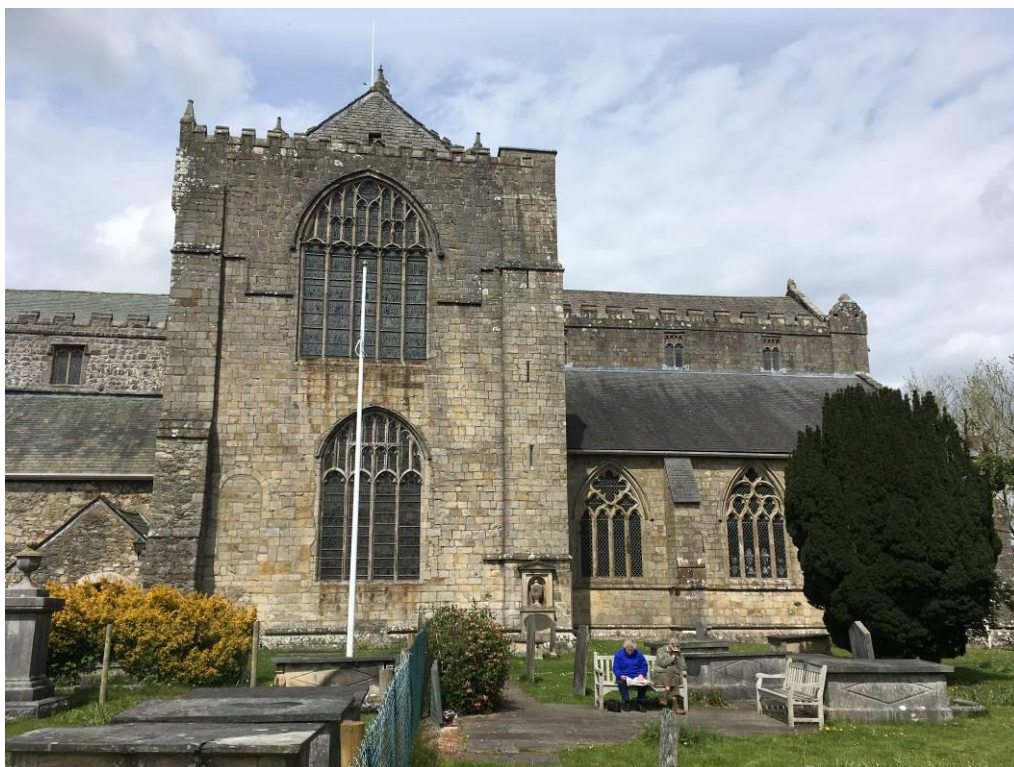
Fig.8: the church from the south

The primary phase (c1189-1219) and 14th century parts of the church (chancel, north and south choirs, transepts and crossing) are built of sandstone quarried from

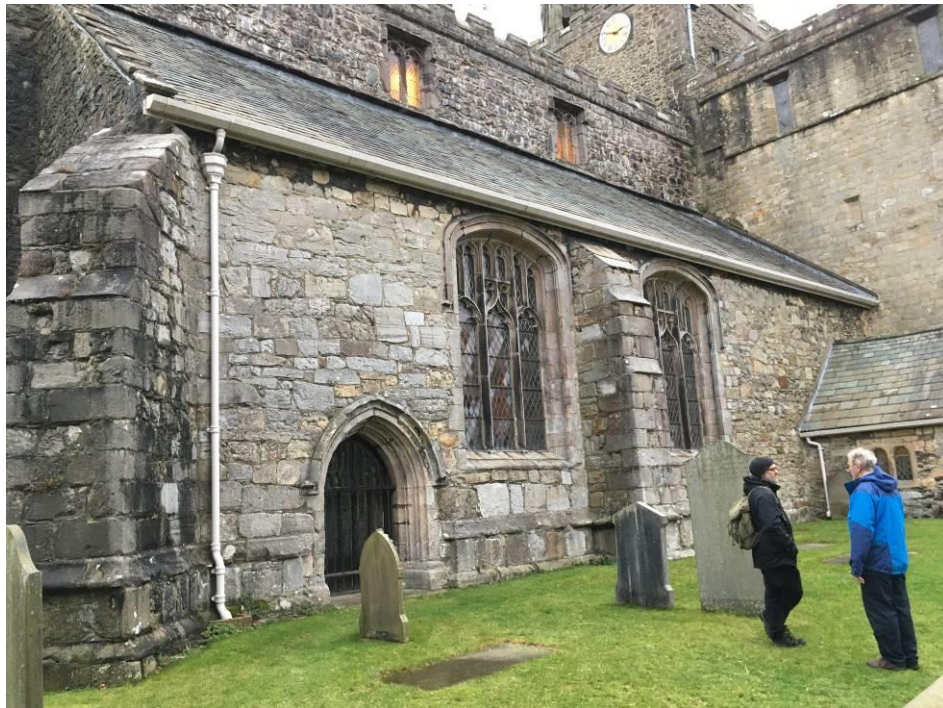
Fig.9: the south aisle, from the south-west

Quarry Flat, laid in large blocks of dressed stone. In contrast, most of the 15th century nave and aisles are built of rubblestone that incorporates a wide variety of stone, including Red Oolite and Dalton limestone, Bannisdale Slate, cobbles of Lower Palaeozoic, volcanic and sedimentary rocks. The building stones and geology of the church are the subject of a study by Murray Mitchell (1990). The nave walls were rendered until the late 19th century but are now fair-faced. Walls have moulded ashlar plinths and string courses with mouldings characteristic of the Early Gothic period (primary phase) or 14th and 15th centuries (later phases). The steeply-pitched roofs are laid with graduated Westmorland slate. Rainwater goods are cast-iron.

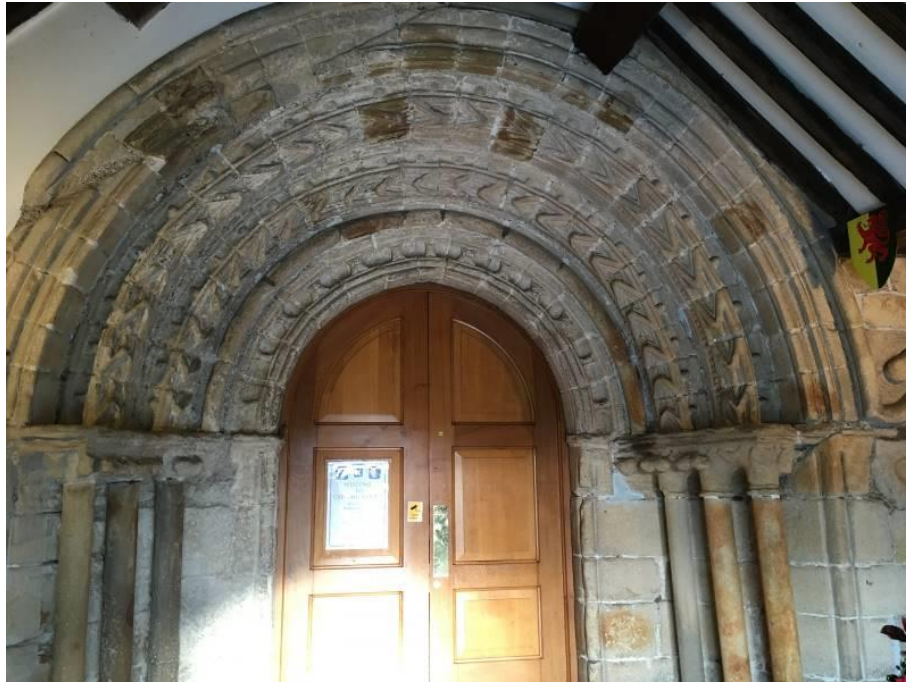
Fig.10: Late 12th century south doorway within later porch

The gabled porch to the south side of the nave was rebuilt in the 17th century, when the outer arched doorway was built. This shelters a fine round-arched inner doorway, one of the earliest elements of the primary phase (c1189-1219). The door is modern (1976). The exterior south wall around and above the porch is poor quality rubblestone, with no plinth; ghost lines in this external wall suggest the line of an earlier porch roof. The south aisle has mid 15th century windows and another south doorway further west of similar date; this part of the wall is built of roughly coursed sandstone on a moulded plinth.

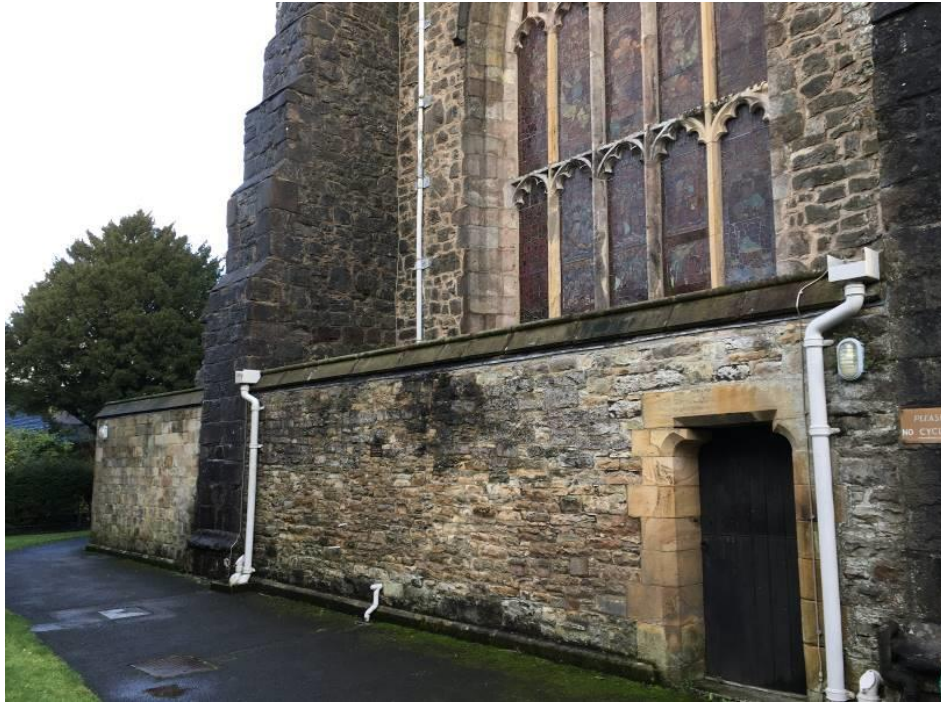
Fig.11: west end with late 19th century addition

The clerestories to north and south side of the nave have simple 2-light windows, and the nave parapet is battlements, all probably 15th century in date. At the west end, the bell cote to the gable may be a later feature. The south-west and north-west corner buttresses incorporate rubblestone walling that may be part of truncated walls that continued westwards, of unknown purpose and date. Between the buttresses to the end of the nave and to the west end of the north aisle a single-storey lean-to store was built as part of the 1860s Paley phase. This has one doorway facing west, copying the form of the internal shouldered-arched doorway.

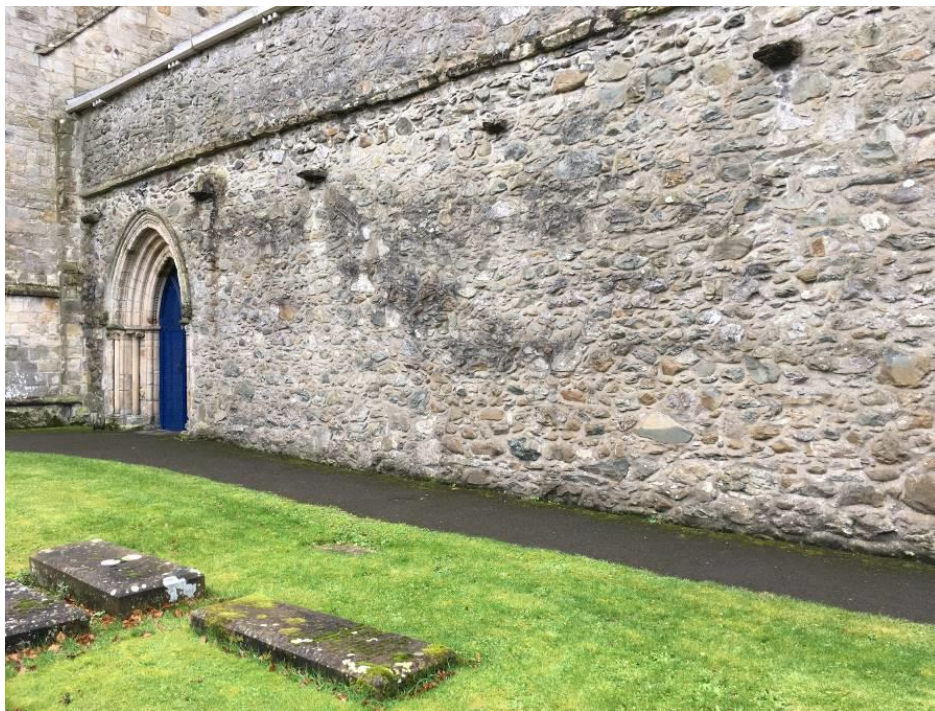
Fig.12: north aisle wall, from north-west

On the north side of the north aisle the key feature is a fine moulded doorway with pointed arch, characteristic of early 13th century Early Gothic (ie. later than the round-arched south doorway, although it may be broadly of the primary building phase). The rest of the north wall is blind; the line of rough stone corbels and the drip course above them indicates a former building against this wall. It is perhaps worth noting that the four stones towards the east end of the drip course are neatly chamfered compared with the much cruder stones to most of the wall. The only other feature visible in the masonry is a rough blocked opening of unknown origin above the doorway, over the dripstone course. No other features are visible.

A higher sloping line of dripstones on the west face of the north transept indicates an intended steeper aisle roof). The north wall would have been rendered before the late 19th century, although there are no historic images of this elevation.

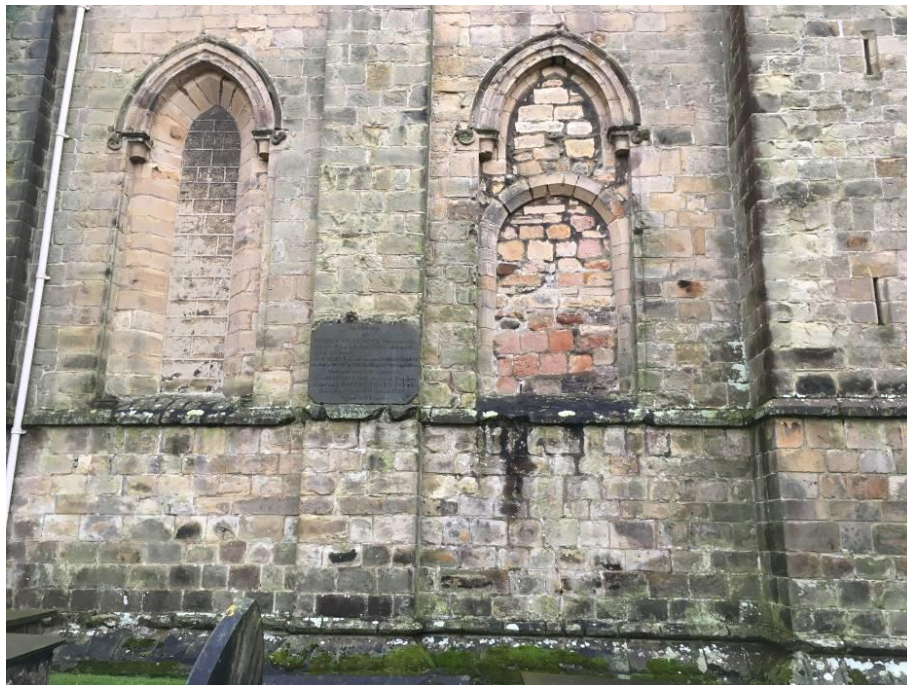
Fig.13: north wall of north transept

The north transept retains evidence for several phases of building and alteration; the pilaster buttresses, plinth with keel moulding, ashlar masonry and blocked lancet windows are part of the primary phase (c1189-1219). This is overlain by later alteration, including the insertion of a round-arched first floor doorway on the north face, which apparently served the upper floor of a 2-storey building attached to the north side of the transept, of unknown date. There are inserted 15th century windows above and to the east face of the transept.

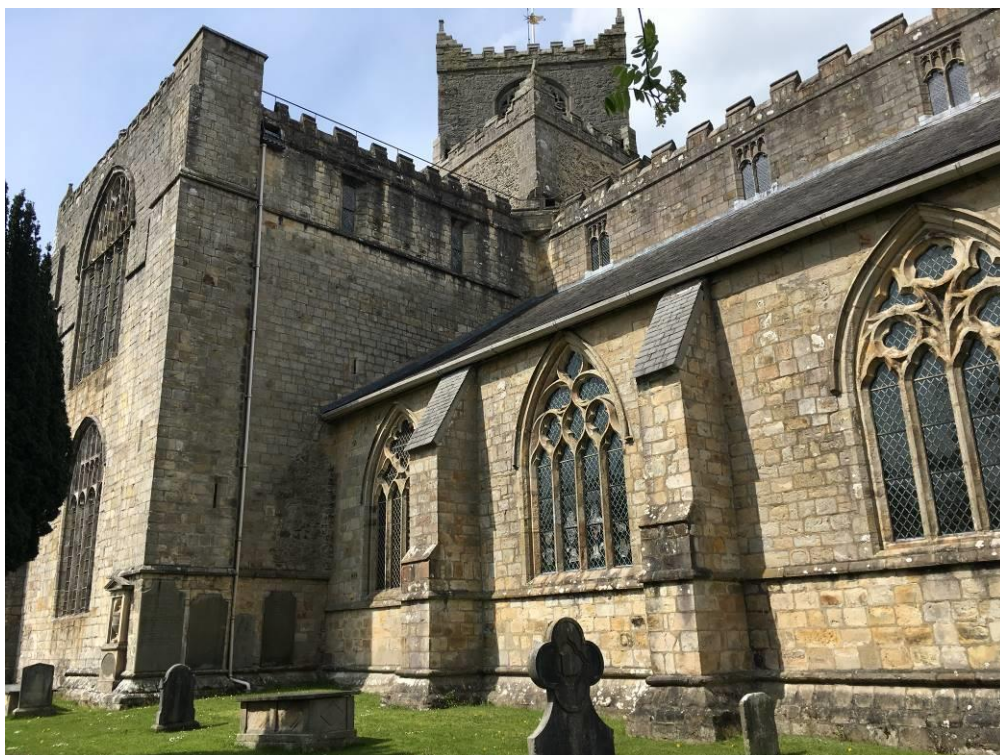
Fig.14: south transept, Town Choir and tower, from the south-east

To the south of the choir, the Town Choir is mid 14th century, a former chapel, with a fine set of windows with flowing Decorated tracery of differing designs, one to the east and three to the south. The masonry, with stepped buttresses and high moulded plinth is also mid 14th century. Both the Piper and Town Choirs have eaves gutters, not parapets to the roofs.

The south transept, like the north transept, expresses several phases with later alterations as an overlay over the primary phase. The windows are 15th century, the lower inserted slightly to right of centre. To its left is a blocked first floor doorway that served the upper floor of an adjoining building, probably forming the east side of the cloister. On both the east and west sides of the transept there are blocked openings in the masonry; the east feature pre-dates the enlargement of the Piper

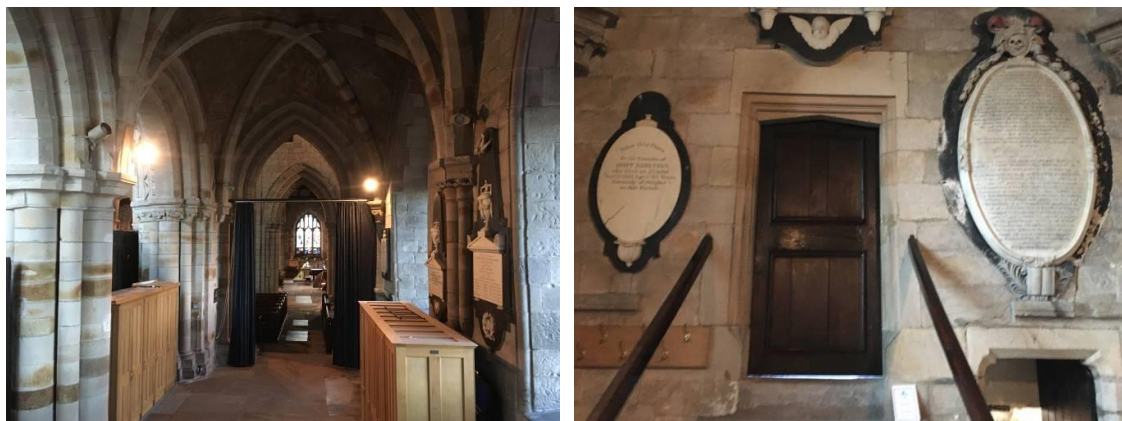
Fig.17: Piper Choir from east (LH) vestry and crypt doorways to east end (RH)

The Piper Choir to the north of the choir retains masonry vaulting from the primary phase, an important survival as the corresponding vaulted roof to the south chapel was destroyed when the Harington chantry chapel was built. The east end of the Piper Choir now comprises a wall with doorways leading to the vestry and crypt below; before the vestry was built in the 17th century, there was a window in this wall (originally over an altar; the piscina is still in the wall to the south). The windows contain fragments of medieval glass to the upper lights. The collection of wall memorials and ledger stones, mainly from the 18th century, includes several to the Knipe and Robinson family. The vestry was remodelled by John Coward, the Cartmel architect in 2000, when the old library was removed and the timber mezzanine floor and staircase were installed.

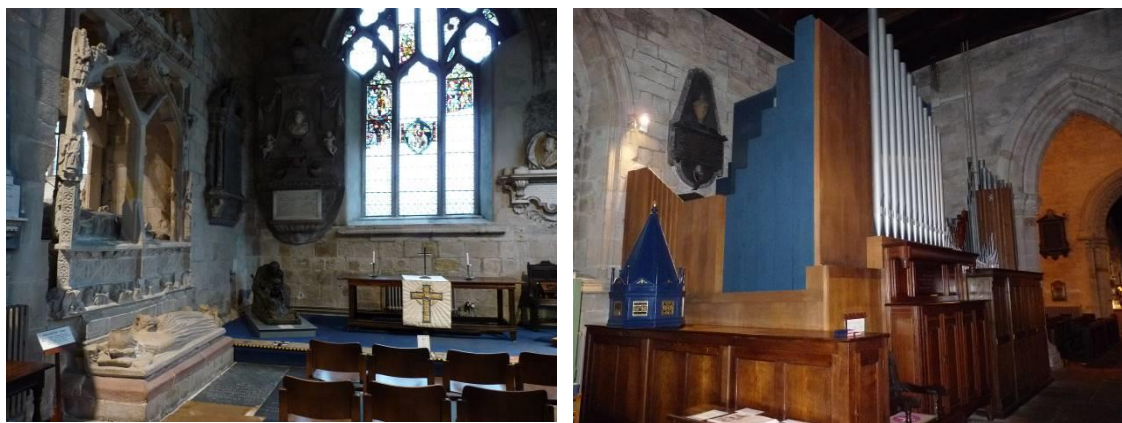
Fig.18: Town Choir from the west with Harington tomb (LH) and organ to south-west corner (RH)

In the Town Choir evidence of the primary phase form of the chapel is provided by the springers for the original vaulting, seen on the north wall. The rest of the chapel structure and windows date from the mid 14th century enlargement. The Harington monument has been the subject of several studies (Roper 1880, Rigge 1881,

Dickinson 1985 and a dissertation by Cameron, 2017) and is not described in detail here. Its present truncated condition and position date from the 17th century, when it was moved into an archway cut into the north wall, from the south-west corner of the chapel. The north wall has a rough rendered finish, obscuring altered masonry. The spatial character of the Town Choir was altered by the insertion of the pipe organ, during the Paley works in the 1860s when the current timber ceiling was installed. The current organ dates from the 1960s and it dominates the south-west corner of the chapel. On the east wall of the chapel is a group of large Lowther memorials, which encroach on the outer lights of the 14th century east window. The stained glass fragments date from c1430, the remains of a Jesse window. The chapel is arranged with a simple altar and modern seating. The tomb with effigy of a prior on the floor in front of the Harington tomb is 13th century.

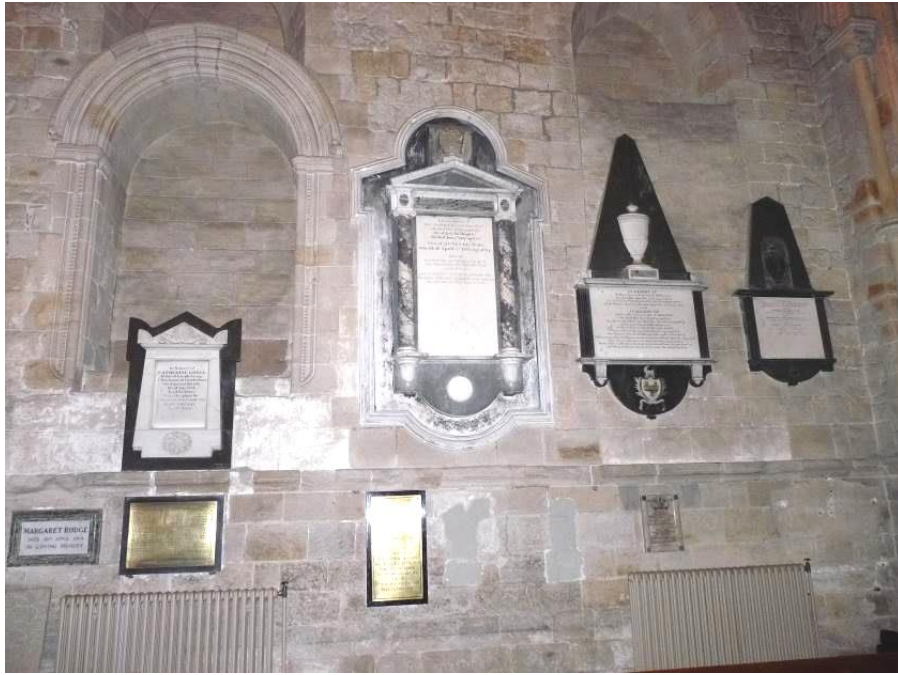
Fig.19: north wall of north transept with blocked openings and later memorials

The crossing and transepts are, like the choir and Piper Choir, of the primary phase with an overlay of later work and fittings. The openings that cut through the earlier lancets appear to re-use some Early Gothic mouldings, although the east window is 15th century. The finely moulded round-arched doorway to the north has Early Gothic mouldings and is cut into a blocked lancet, suggesting it was a later part of the same primary phase, perhaps a change of plan. Both transepts have a rich archaeology that would merit modern measured survey and analysis to further our understanding. The roofs of 15th century collar rafters were exposed during the 1850s Paley work, and the seating is from the 1860s Paley phase. The east window glass in the north transept is dated 1892, a memorial to Edward Cavendish by Shrigley and Hunt. Both transepts contain wall memorials, mainly from the 18th and 19th centuries, with a few from the 17th century.

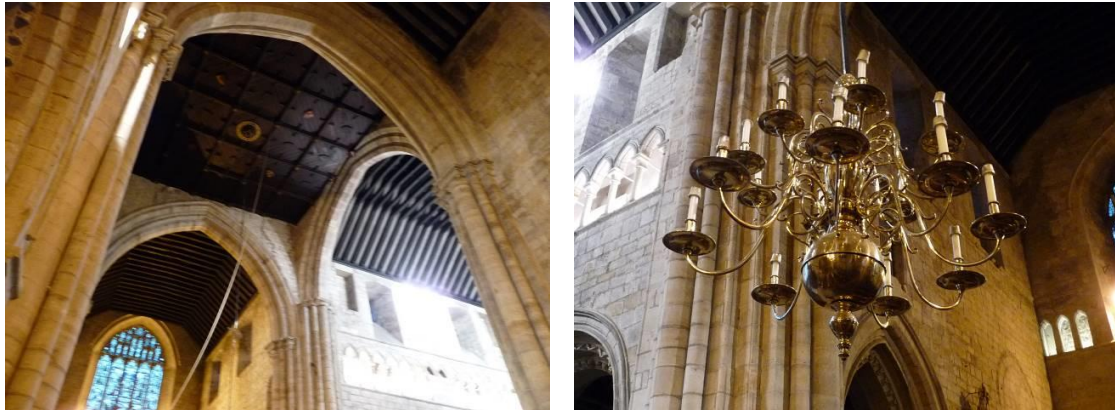
Fig.17: the crossing with ceiling of 1850 (LH) and early 18th century candelabra (RH)

lectern and a fine early 18th century candelabra, the gift of the Marshalls of Aynsome in 1724. The oak desk is dated 1907.

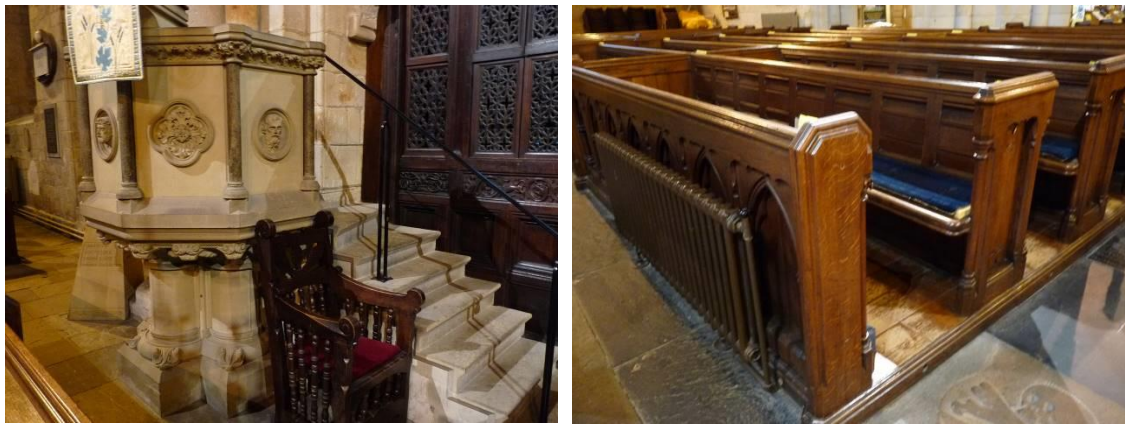
Fig.18: Paley pulpit, 1860s (LH) and oak benches on timber platform (RH)

The character of the nave contrasts with the finely detailed masonry of the eastern part of the church, with rubblestone walls and 3-bay arcades built during the 15th century phase. When finished in lime plaster, the nave would have been a brighter space. The spaciousness of the nave is partly due to the recent removal of Victorian pews to create a large flexible space for events. The roof is the same collar-rafter construction also used in the choir and transepts, and exposed during the 1850s. The floor is laid with stone, partly re-laid in 2018, with ledger stones in aisle areas. The low doorway to the west end has a shouldered-arched head, similar to the doorway to the crypt from the Piper Choir; this doorway type is also known as a Caernarvon

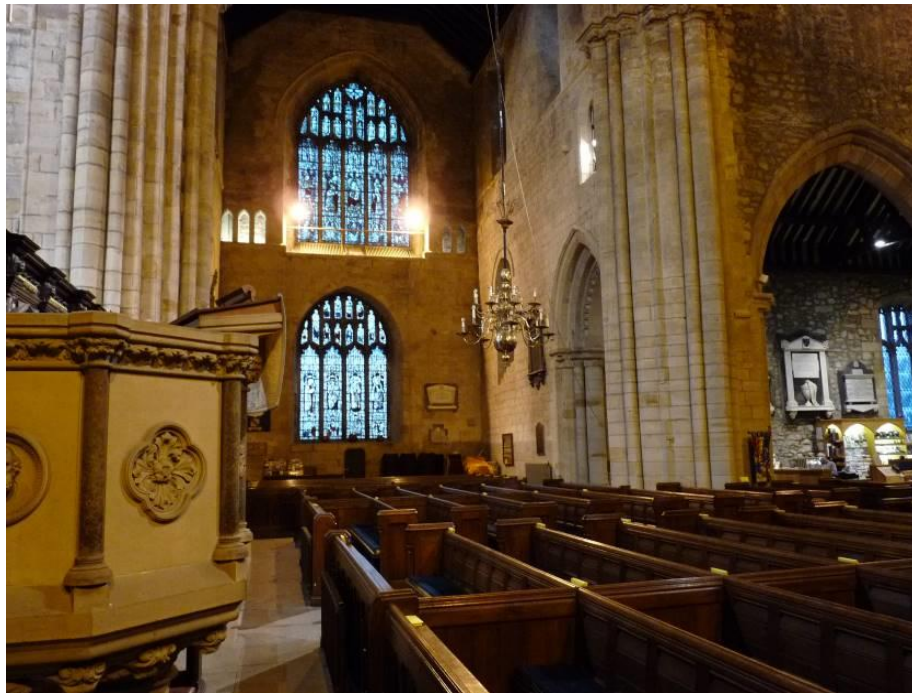
Fig.19: south transept from the crossing

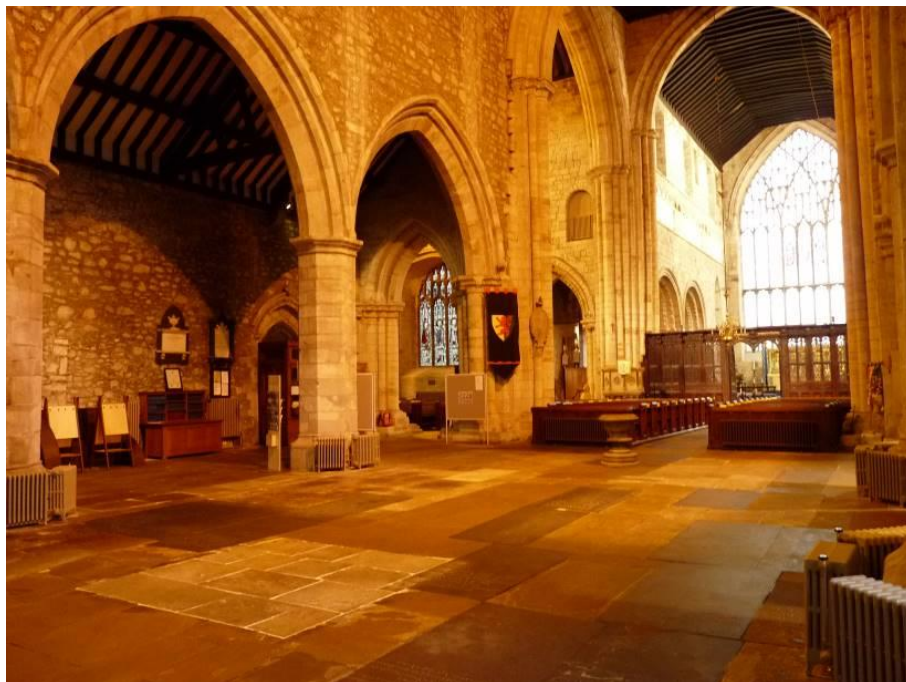
Fig.20: nave from the south- west

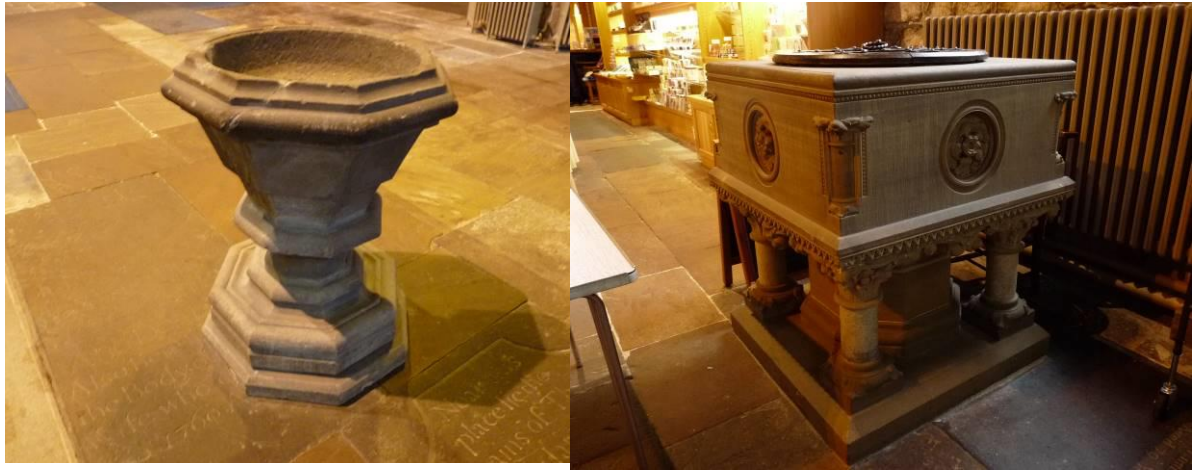
Fig.21: re-set font in nave (LH) and Paley font re-set in south aisle (right)

The font is an octagonal moulded stone vase, recently re-sited in the nave. It was altered in 1833 and previously had a plinth and 17th century timber cover; its original date is not known; it may be late medieval or later. The square stone font on columns, designed by Paley is a typical example of gothic revival design by the firm. It is now in the south aisle, at the west end of the book stall. The book stall has been in this location since the 1980s and was last refitted in 2010. The oak doors into the east doorway on the south wall were installed in 1976.

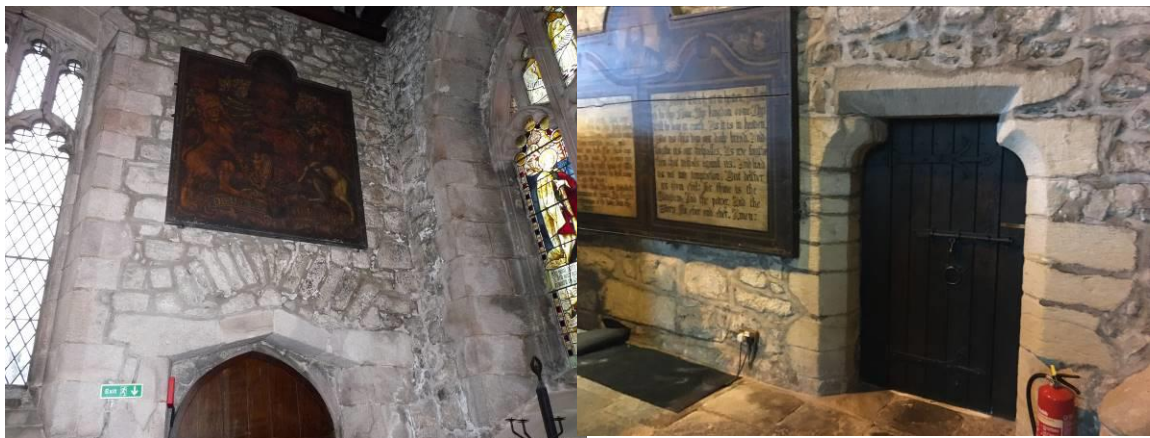
The two 17th century prayer boards at the west end of the nave are dated to 1681; mounted on the wall, they are reputed to have been on the top of the choir screen. The glass in the west windows dates from the 1880s, given by local families, and is by Burlison and Grylls (west nave) (Hyde and Pevsner, 2010, 271) and Shrigley and Hunt (west aisles). Above the Cromwell door (south wall) are the Royal Arms of Charles II.

Fig.21: Royal Arms over south-west door (LH), prayer boards and west doorway (RH)

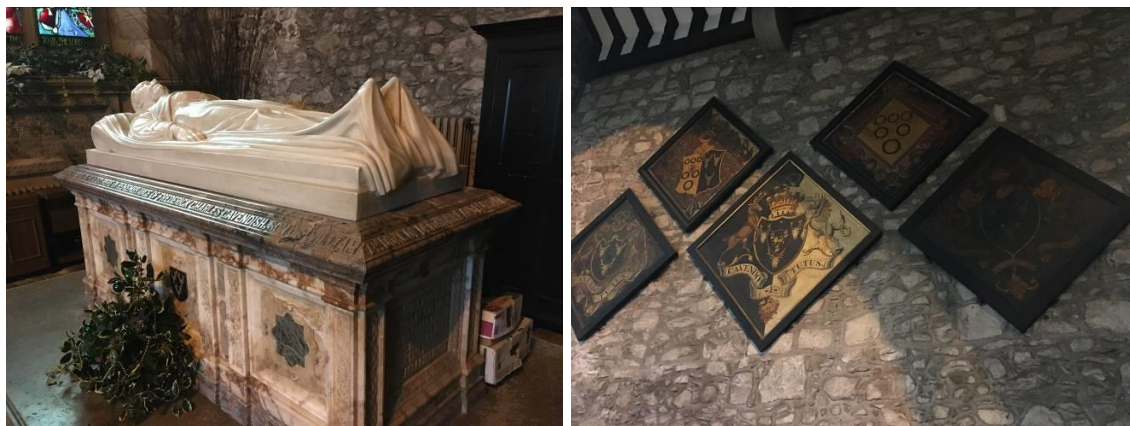
At the west end of the north aisle is a large memorial to Lord Frederick Cavendish, who was killed in Dublin in 1891. The alabaster plinth was designed by H.J.Austin and the effigy is by Thomas Woolner. The hatchments on the north wall are of the Cavendish and Lowther families, owners of Holker.

Fig.22: Cavendish memorial and hatchments in north aisle

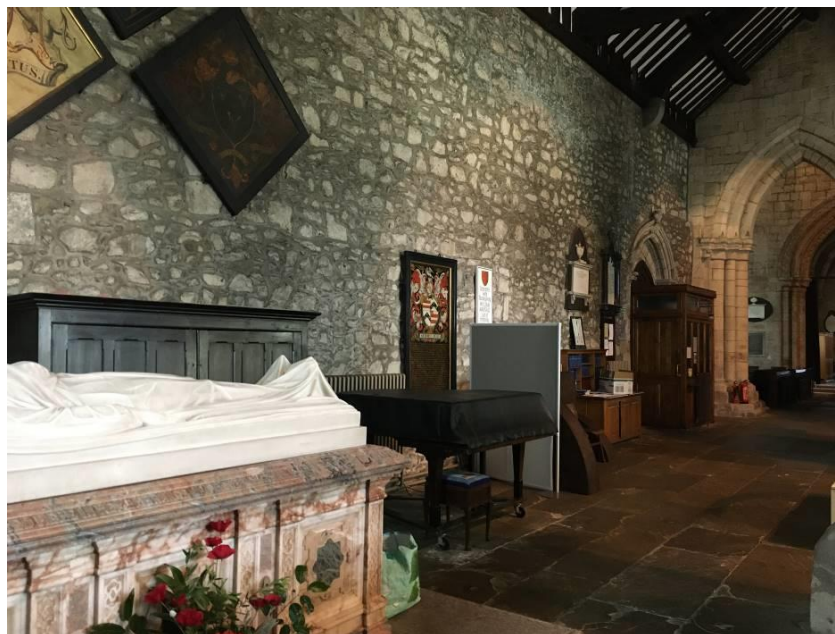
The north aisle has no windows and is thus a dark area of the church. The rubblestone walls appears to be of different phases, with a shallowly projecting section approximately 2 metres high towards the west end of the wall, with a corner at its east end finished with rough quoins (see Figs 23 and 24). There is no means of dating this masonry, however.

Fig.23: north aisle from the west

Also on the north wall is an important record of George Preston's role in repairing the church in c1618; the painted wooden board was erected in 1646 and lists the work he carried out. To the east of this is a pair of marble memorials to James Atkinson (died 1830) and John Walker (died 1839). The north doorway is largely hidden by a timber screen, probably installed in the early 20th century. Although the outer part of the doorway appears to be of the primary phase, it may have been re-set into this rubblestone wall in the 15th century.

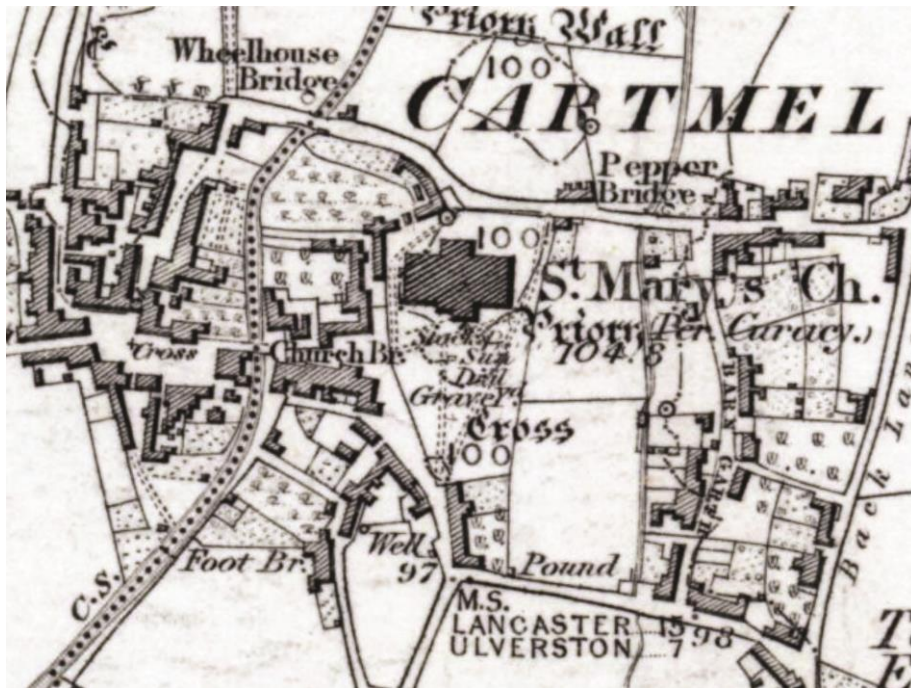
Fig.27: Ordnance Survey, 1851 1st edition, Lancashire Sheet 17, 1: 10,560, surveyed 1847-1848
